**SUBJECT:** A construction worker jumps over a cement barrier onto an interstate highway transition road and is killed when struck by an oncoming vehicle.

**SUMMARY**  
**California FACE Report #02CA003**

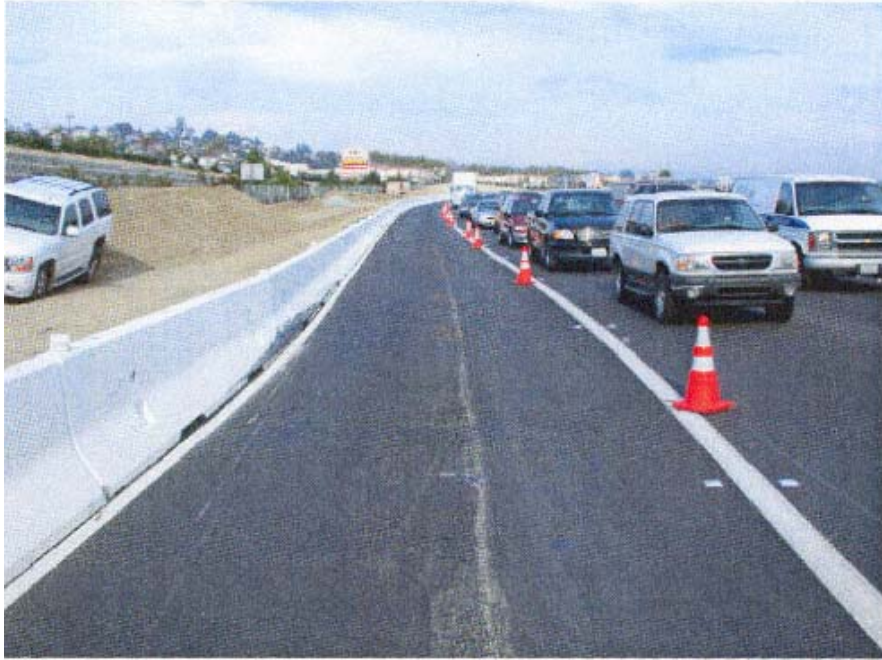
Exhibit #1

View of the "K" rail used to separate the work area from on-coming traffic looking east.

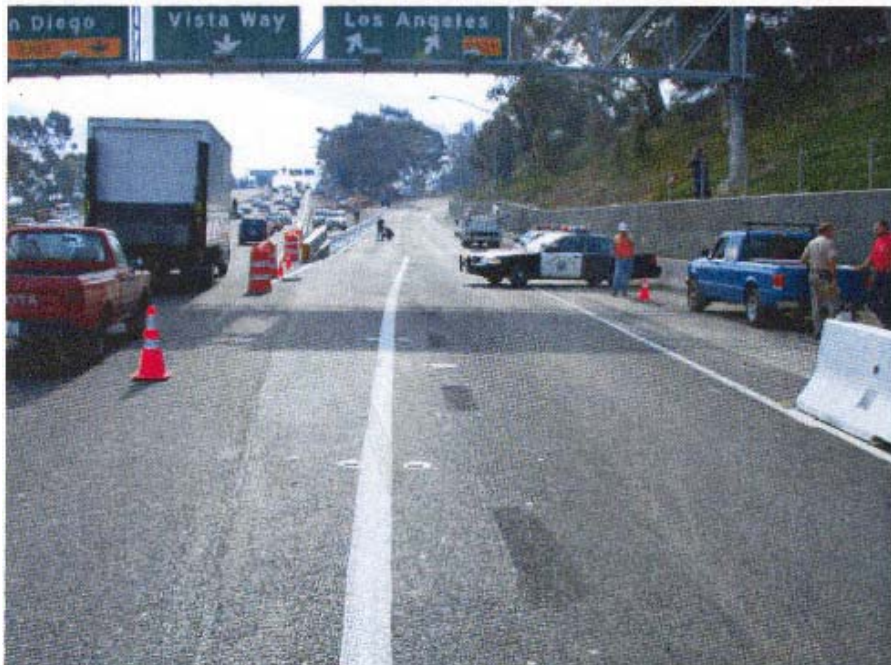
Exhibit #2

View of the transition road where the incident occurred looking west.

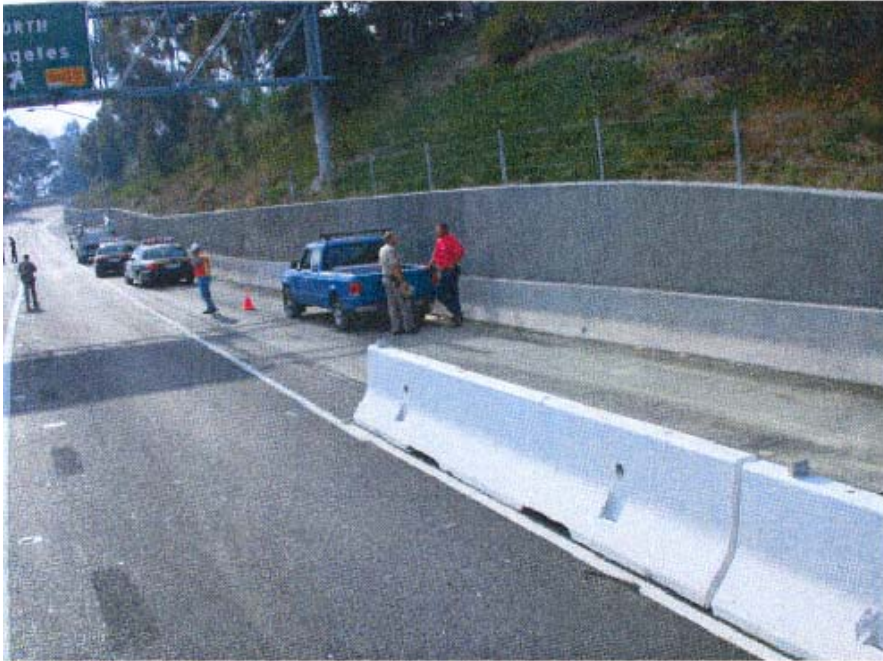
02CA003  
Exhibit #3

View of the end of the protective barrier that the victim jumped over.

**Recommendation #1: Ensure employees remain within the safe work zone designated by protective barriers.**

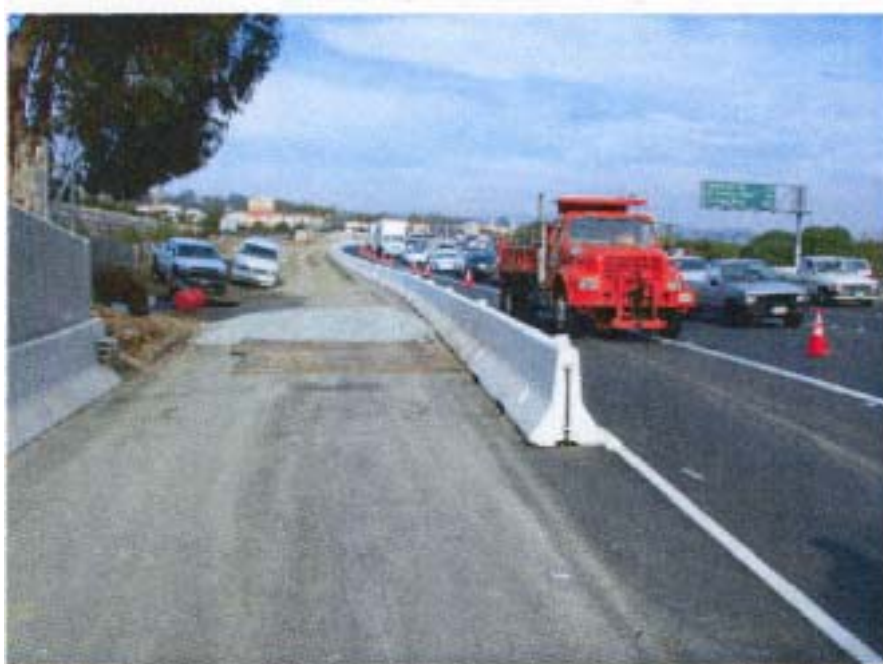
02CA003  
Exhibit #4

View of the work area where the victim was working.

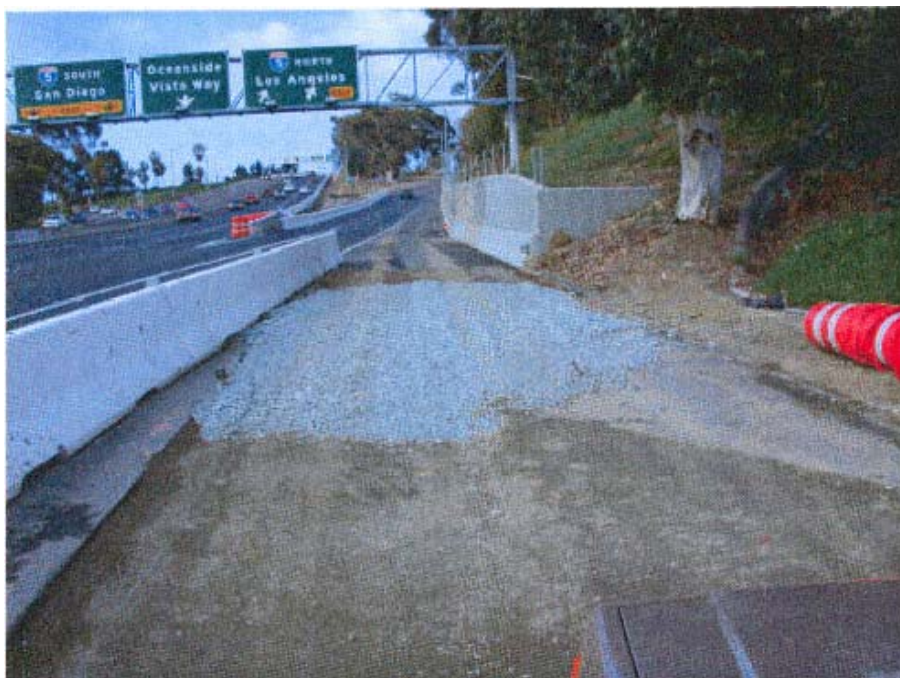
Exhibit #5

View of the work area looking toward the transition road where the incident occurred.
